76  
galvanize  
June 2015

Asia Pacific Edition  
HOT DIP GALVANIZED STEEL

# CHANGES TO AS/NZS 2312 ON HOT DIP GALVANIZING

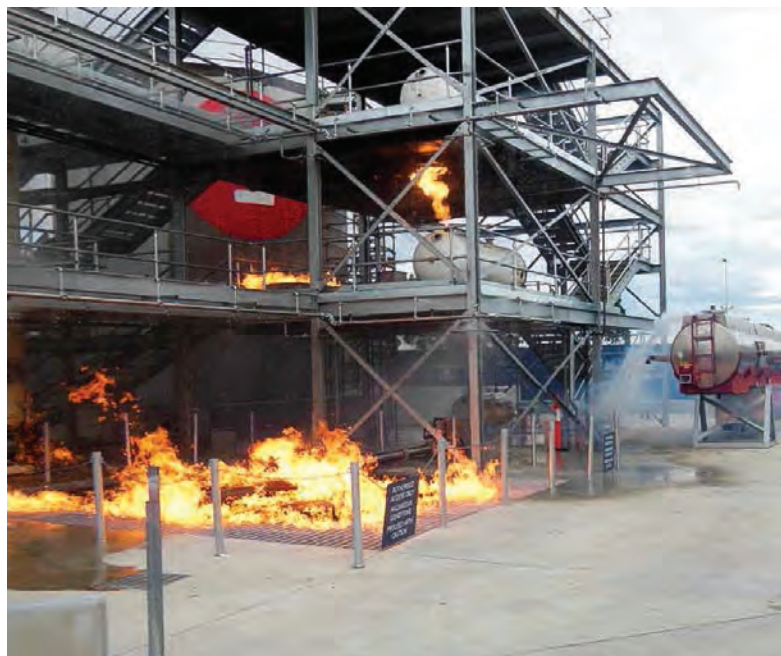
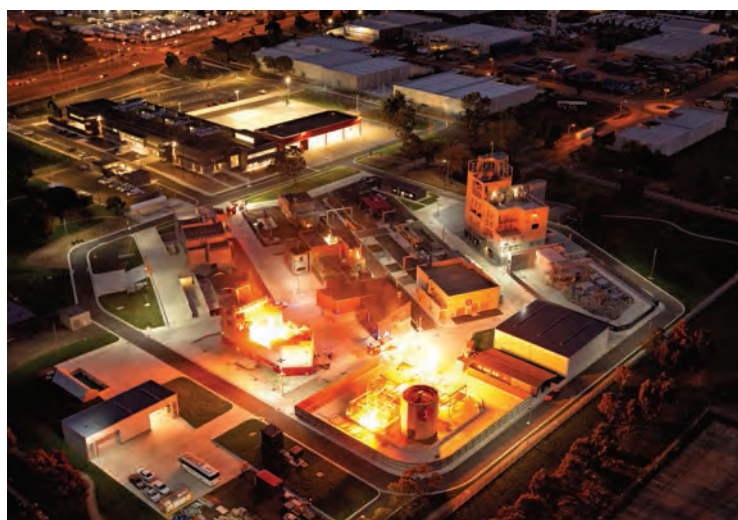
*The Victorian Emergency Management Training Centre in action.  
Photo courtesy of Major Projects Victoria*

This job is unique in that it is believed to be the first project of this sort to use HDG steel to such an extent. The use of HDG steel also means little maintenance is required by facility managers after each training session and during the life of the product.

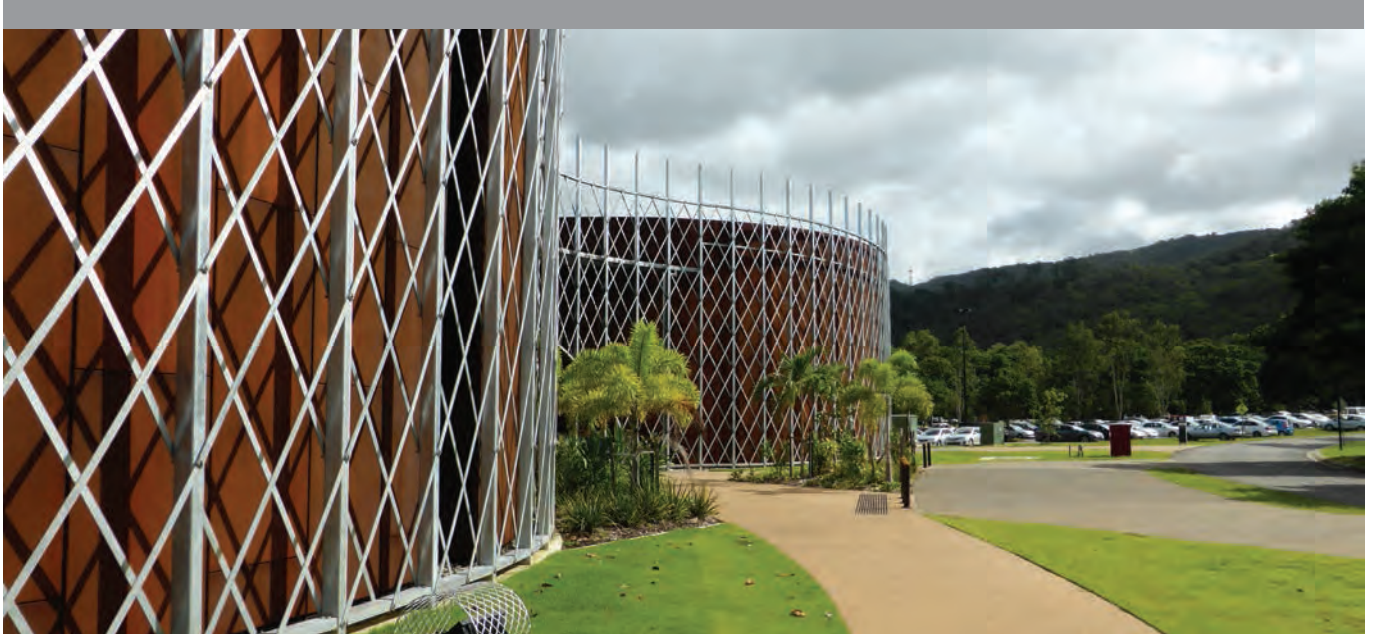
*Hot dip galvanizing and weathering steel combine to provide a stunning contrast clearly visible from the nearby main road.*

The Cairns Institute building is encompassed by a super-sized hot dip galvanized steel lattice skin, or 'trellis', shielding the building whilst connecting it to its tropical rainforest setting. Among other elements it comprises over 4km of HDG strapping and 10,000 structural bolts with around 58 tonnes of galvanized steel in total.

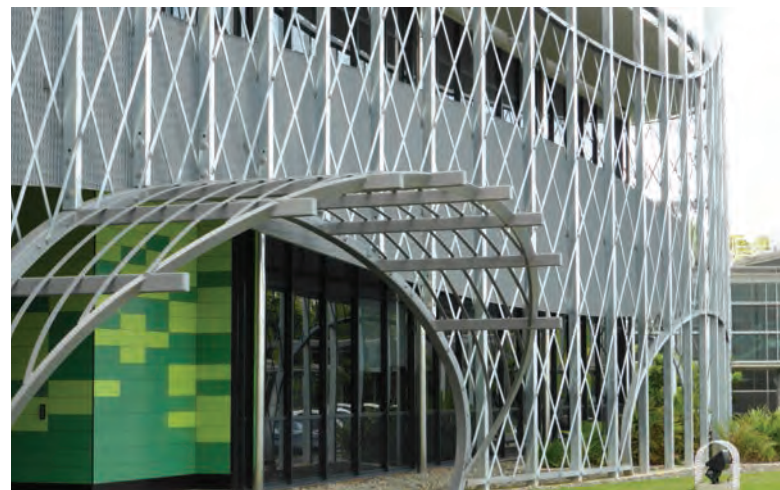
*Here the hot dip galvanized trellis combines with a modern skin to complete the building entrance.*

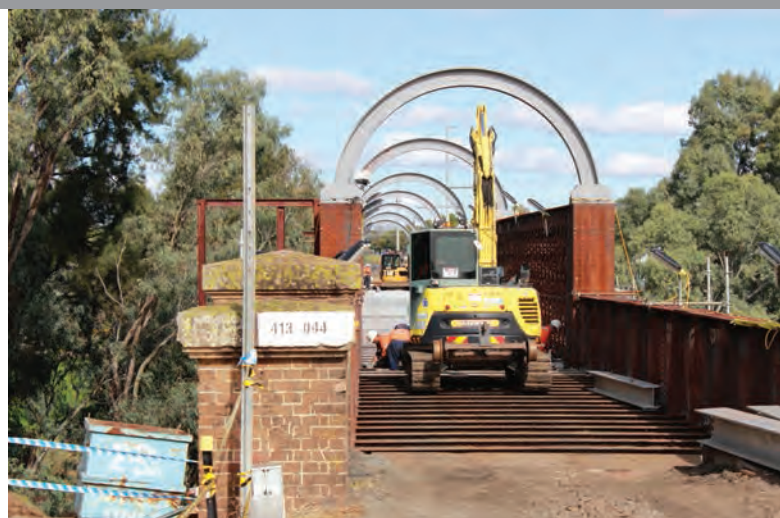
*Installation of over 300 galvanized cross-braces required a round-the-clock effort to ensure this vital bridge link was returned to operation on schedule.*

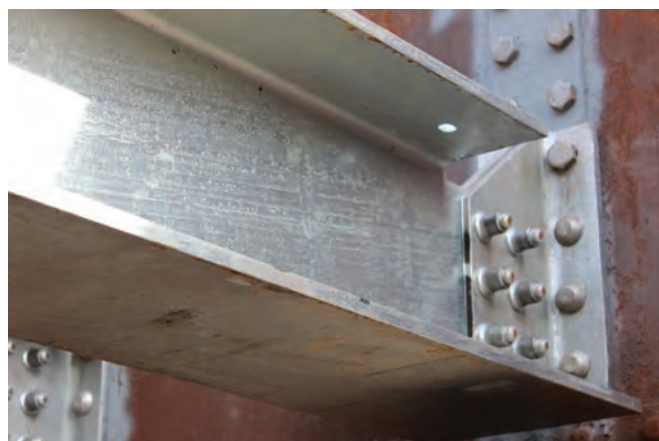
*Riveted fasteners were replaced to facilitate speedy removal of the old cross-beams during the 16-day outage.*

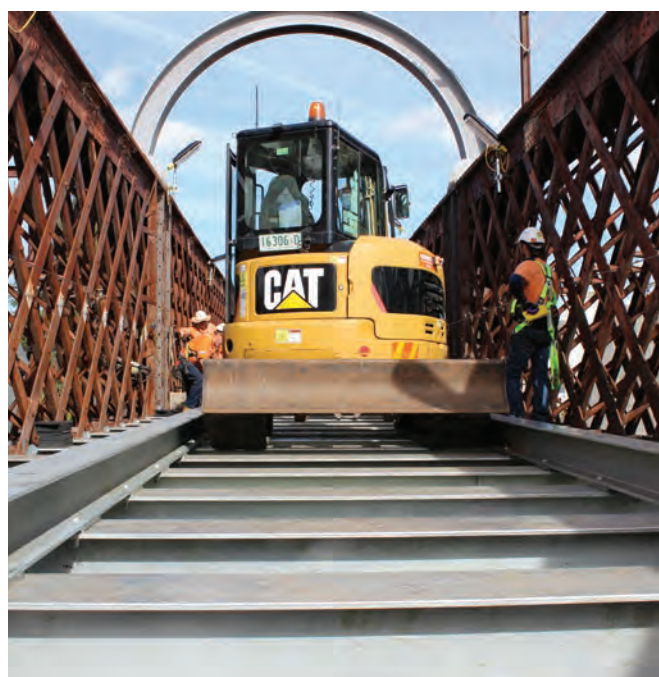
*Galvanized stringers being secured to the newly-installed cross-braces.*

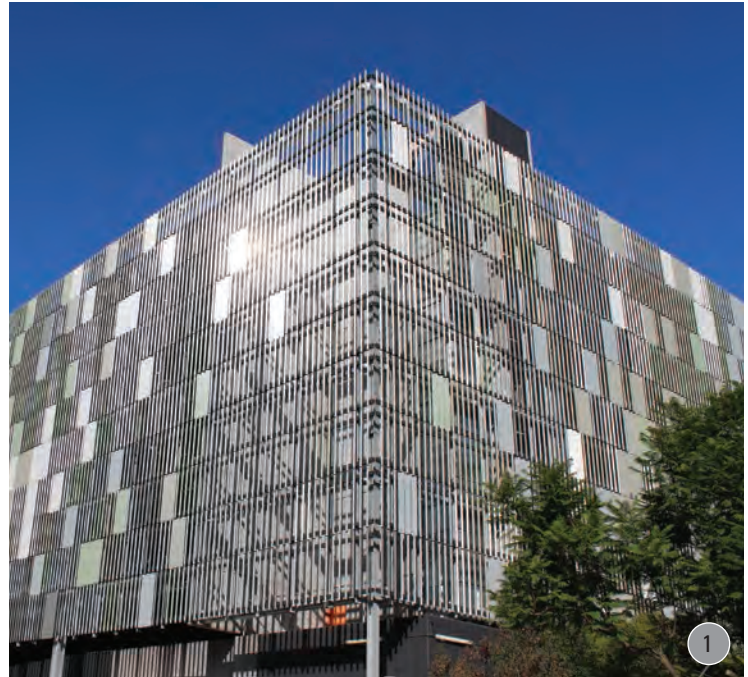
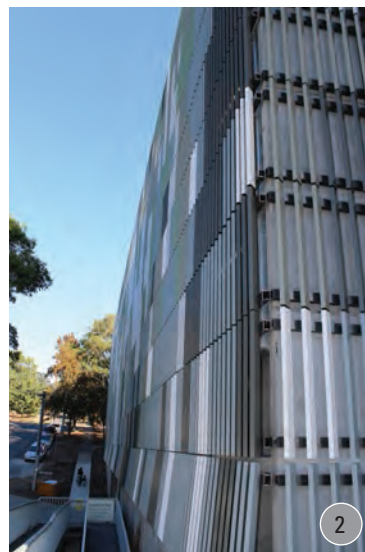
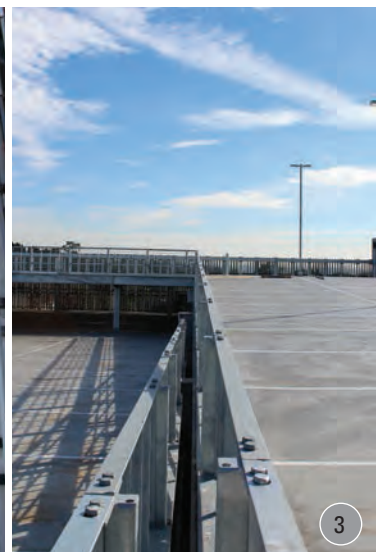
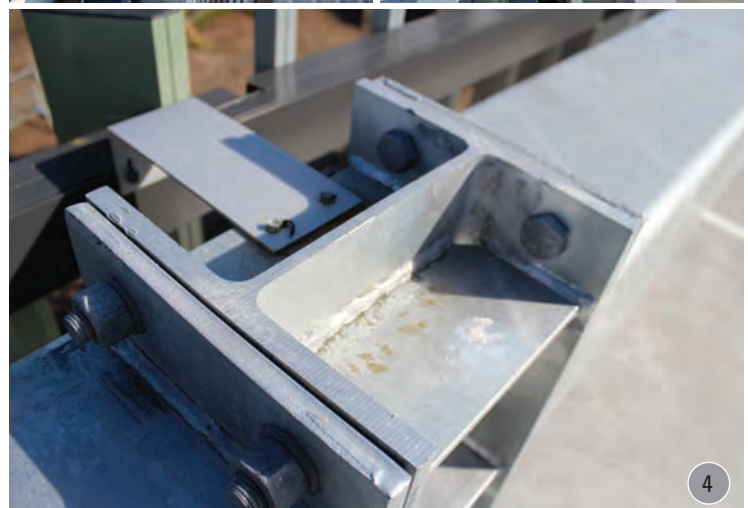
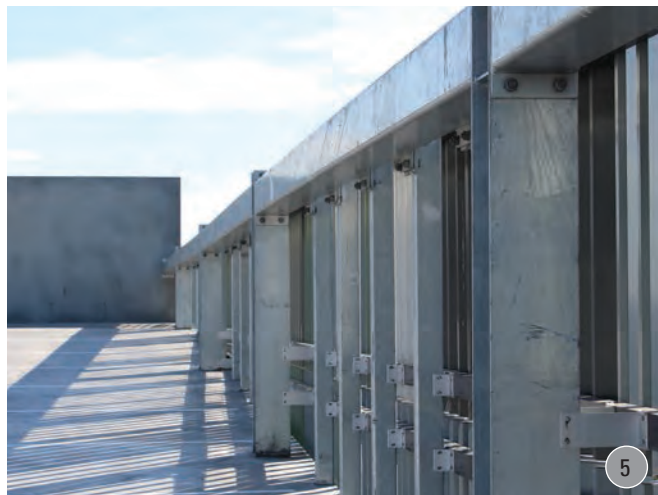
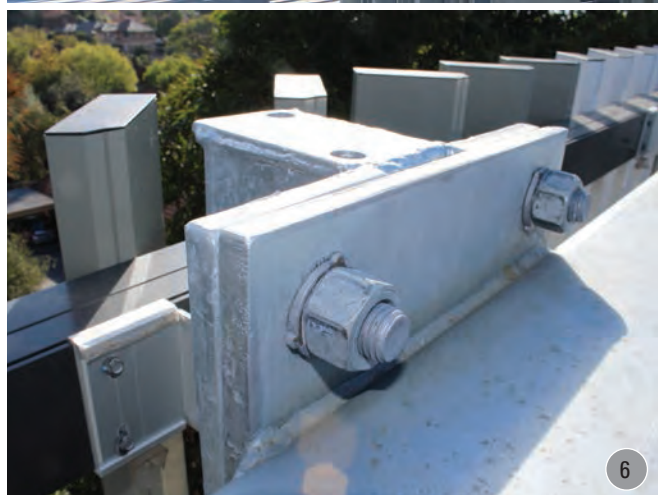
1. The extension of the Austin Hospital car park made extensive use of a galvanized structural steel frame and reinforced concrete, combined to produce a stunning and attractive addition.
2. The installation of angled louvers to the galvanized framework produce a colourful, patterned exterior that creates delightful reflections from the sunlight. It also provides significant ventilation and breaks up the angular lines of the car park structure.
- 3-6. Extensive use of HDG fasteners complement the overall design and allow for significantly reduced assembly time and costs.
7. Fully exposed galvanized steel beams support Bondek which has been used to form up the reinforced concrete slab that creates the next parking level.

To enable shear studs to be welded to the hot dip galvanized beams, stop-off or masking paint in different widths was applied to specified beams to prevent the zinc coating bonding to the steel during galvanizing. The galvanizer treated over 2000 individual pieces this way.
