# CHANGES TO AS/NZS 2312 ON HOT DIP GALVANIZING

The new Part 2 of the AS/NZS 2312 Standard on hot dip galvanizing (HDG) allows designers to more accurately estimate the durability of HDG coatings whilst providing detailed specification advice for duplex coatings, the effect of the steel chemistry and illustrating good design practice.

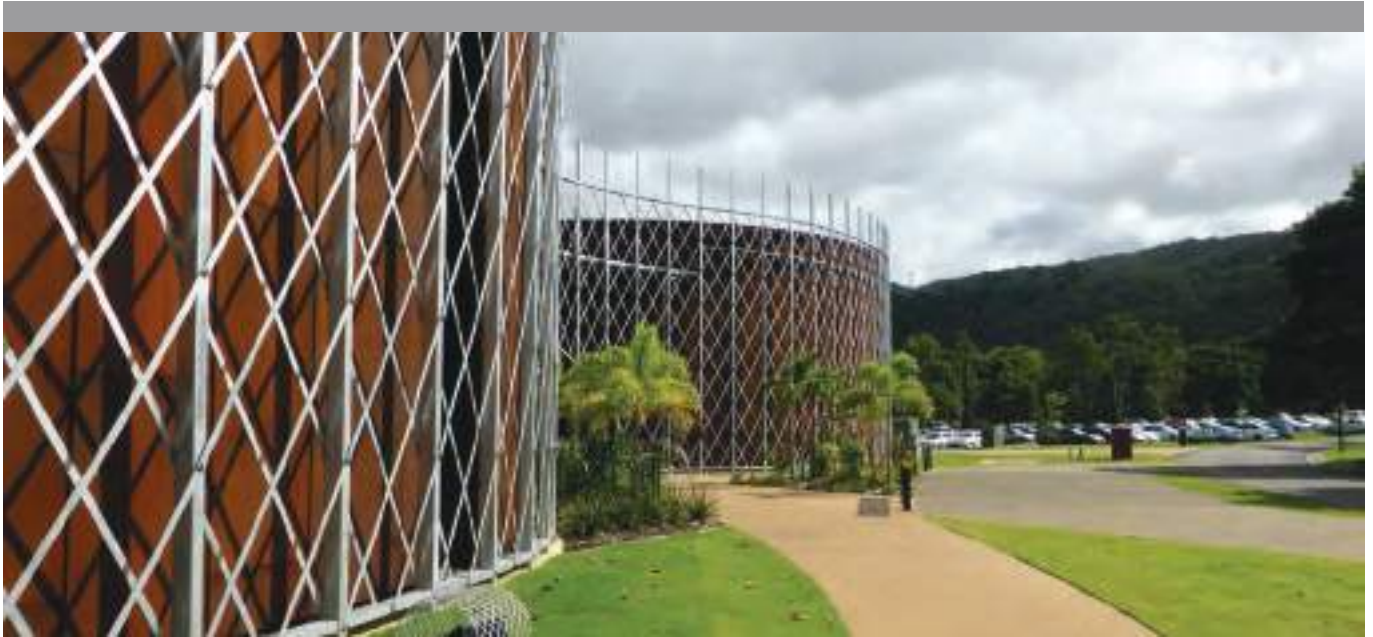
*Hot dip galvanizing and weathering steel combine to provide a stunning contrast clearly visible from the nearby main road.*

The Cairns Institute building is encompassed by a super-sized hot dip galvanized steel lattice skin, or 'trellis', shielding the building whilst connecting it to its tropical rainforest setting. Among other elements it comprises over 4km of HDG strapping and 10,000 structural bolts with around 58 tonnes of galvanized steel in total.

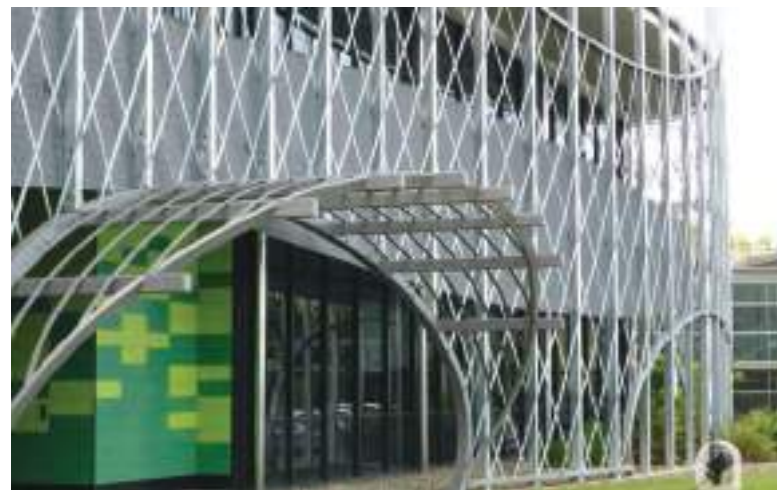
*Here the hot dip galvanized trellis combines with a modern skin to complete the building entrance.*

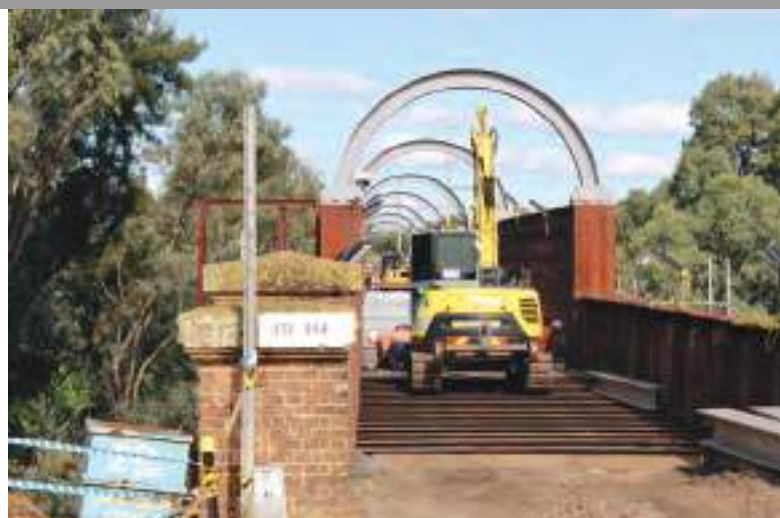
*Installation of over 300 galvanized cross-braces required a round-the-clock effort to ensure this vital bridge link was returned to operation on schedule.*

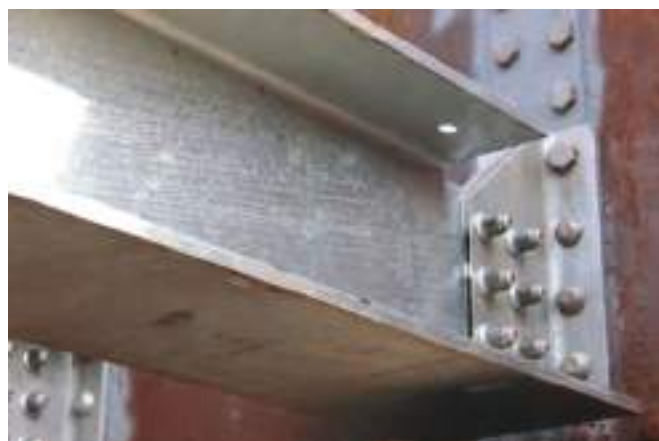
*Riveted fasteners were replaced to facilitate speedy removal of the old cross-beams during the 16-day outage.*

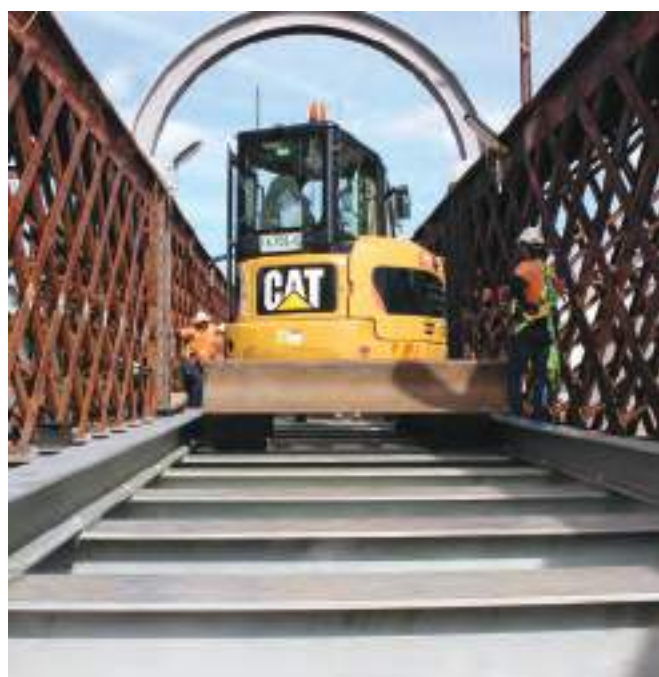
*Galvanized stringers being secured to the newly-installed cross-braces.*

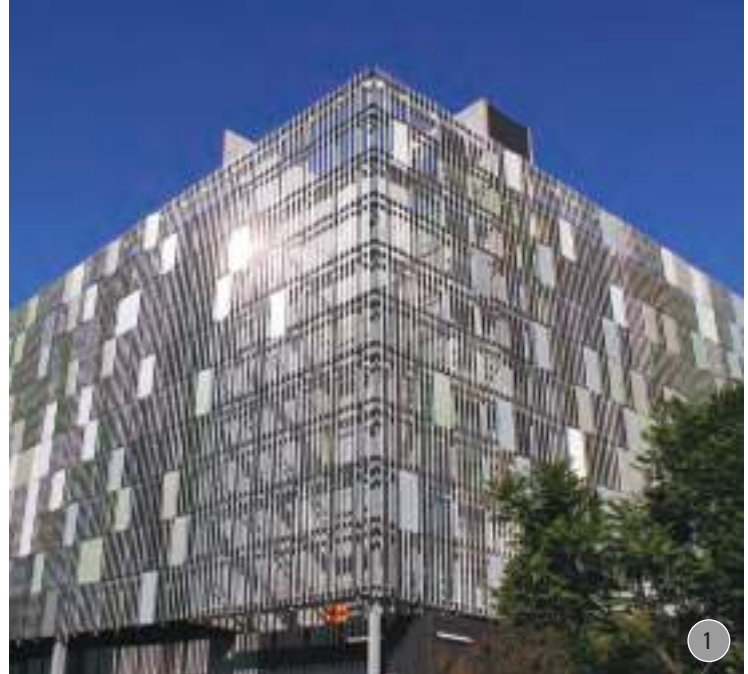
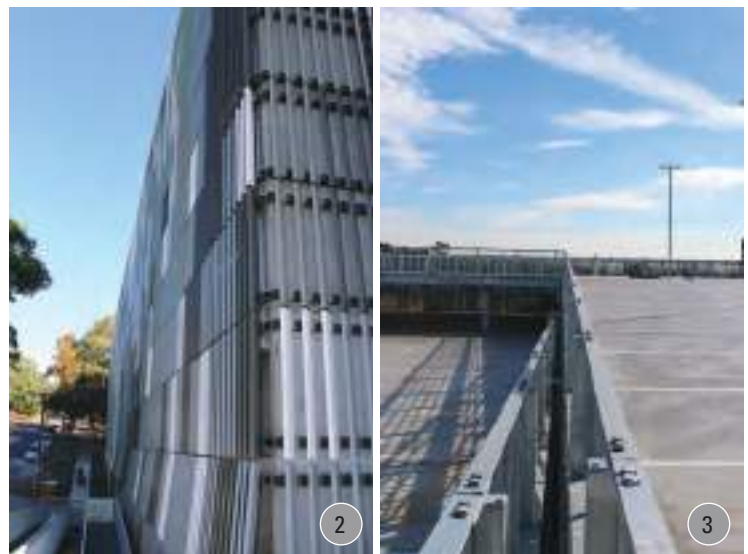
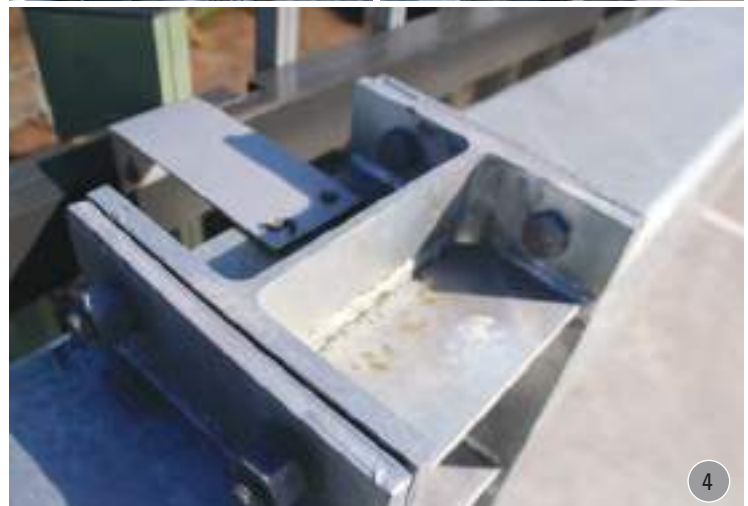
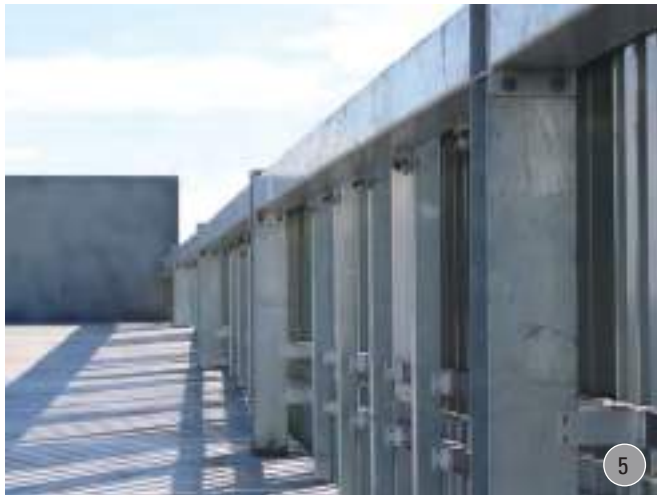
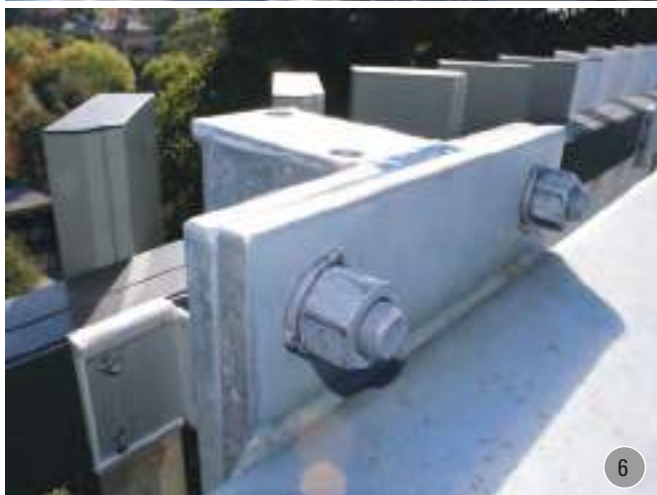
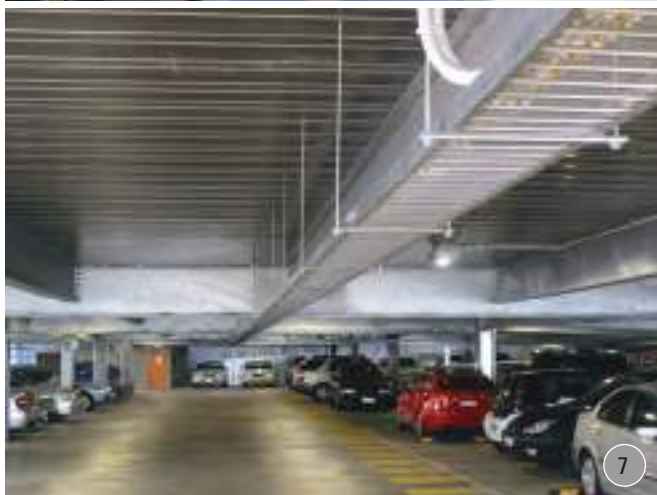
1. The extension of the Austin Hospital car park made extensive use of a galvanized structural steel frame and reinforced concrete, combined to produce a stunning and attractive addition.
2. The installation of angled louvres to the galvanized framework produce a colourful, patterned exterior that creates delightful reflections from the sunlight. It also provides significant ventilation and breaks up the angular lines of the car park structure.
- 3-6. Extensive use of HDG fasteners complement the overall design and allow for significantly reduced assembly time and costs.
7. Fully exposed galvanized steel beams support Bondek which has been used to form up the reinforced concrete slab that creates the next parking level.
